**Flood Control Project Maintenance
Levee Inspections**

Maintenance Issue Types Only, Levee Inspection Report By Mile - Fall 2014

Reclamation District No. 2031 Elliot

Waterway	Bank	Unit Miles	Inspection Start/End	Inspector
Unit No. 01 Stanislaus River	Left	7.07	11/04/2014 11/04/2014	Maksim Khashchuk

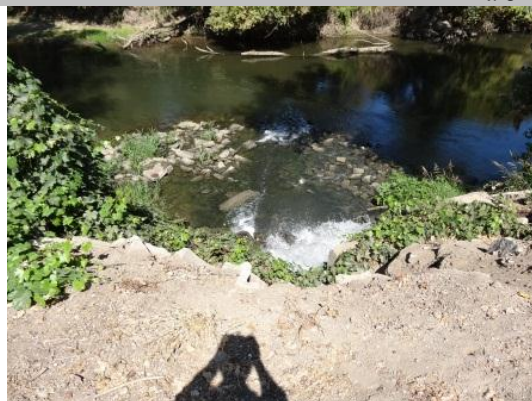
Photo 1 of 1 : SJR2014_RD2031U01RM0.48_1.jpg

LM Start	0.47	Rating **	M	Issue No.	1
LM End	0.50	Issue Type +	Ma	Location *	WS
Category	Supplemental			GPS Latitude/Longitude	
				Start	End
Item	DWR Erosion Survey			37.704740 °	37.704740 °
				-121.159140 °	-121.159140 °
DWR ID

Inspector Comments: 07/31/2014: No significant change observed.
 09/10/2013: No significant change observed.
 07/18/2012: No significant change observed.
 08/18/2011: No significant change observed on site. Debris that blocks the irrigation outlet is visible.
 10/19/2010: No significant change observed on site. Sloughing of the bank is occurring adjacent to an irrigation outlet structure. There is moderate to heavy vegetation along the bank that is well established. Broken chunks and slabs of concrete are used as rip rap and line the outside of the irrigation outlet structure. However, much of the rip rap along the slope is sloughing and could possibly lead to future slope instability.
 08/05/2010: Recommended as a local maintenance issue, per CLRO.
 08/20/2009: No major change observed since last visit; 1 inch fissure cracks developing on the slope; rip rap is showing signs of sloughing; recommend as local maintenance issue; site was previously rated "U".

2008: No change from previous year; irrigation outlet located on site; rip rap placed on river bank.
 09/06/2007: Near agricultural diversion; only 3' landside height differential. [2014 Site ID:RD2031U01RM0.48]

Looking down at the site. The irrigation outlet is operating. Debris is visible at the outlet.

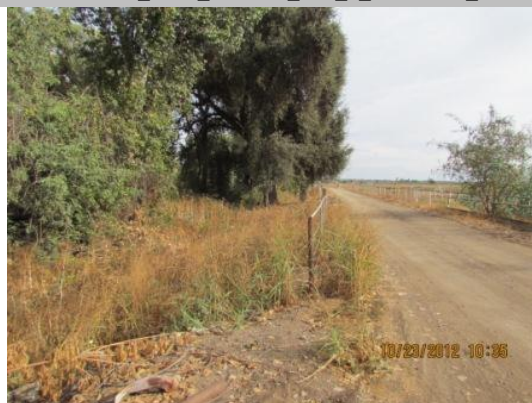
Photo 1 of 2 : FA_2014_RD2031_307_2_20141001_00002.jpg

LM Start	0.52	Rating **	M	Issue No.	2
LM End	0.52	Issue Type +	Ma	Location *	WS
Category	Earthen Levee			GPS Latitude/Longitude	
				Start	End
Item	Vegetation			37.704050 °	37.704050 °
				-121.159578 °	-121.159578 °
DWR ID	DWR RD2031 01 s 2012 2

View of vegetation on waterside slope. Facing upstream.

Remove the wild growth other than native grasses from the levee slopes.

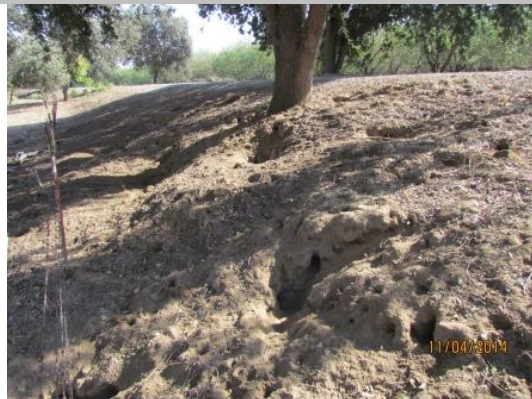
Photo 1 of 1 : FA_2014_RD2031_307_52_20141104_00059.jpg

LM Start	1.63	Rating **	U	Issue No.	52
LM End	1.63	Issue Type +	Ma	Location *	WS
Category	Earthen Levee			GPS Latitude/Longitude	
				Start	End
Item	Animal Control			37.698334 °	37.698334 °
				-121.175176 °	-121.175176 °
DWR ID	DWR_RD2031_01_f_2013_52				
Action/Comments					
No rodents visible, but rodent burrows visible; need to backfill and compact or grout burrows.

View of the multiple large rodent hole in the waterside levee slope.

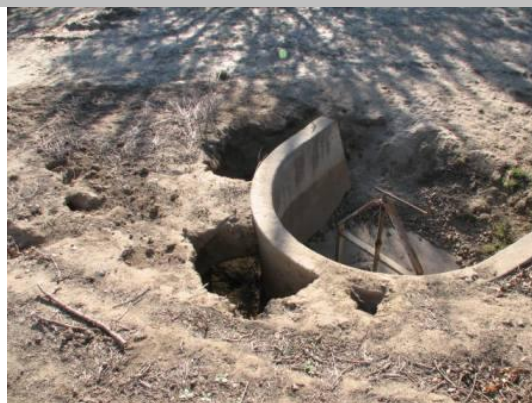
Photo 1 of 1 : FA_2014_RD2031_307_9_20141001_00011.jpg

LM Start	1.65	Rating **	M	Issue No.	9
LM End	1.65	Issue Type +	Ma	Location *	LS
Category	Earthen Levee			GPS Latitude/Longitude	
				Start	End
Item	Erosion / Bank Caving			37.698208 °	37.698208 °
				-121.175400 °	-121.175400 °
DWR ID	DWR_RD2031_01_s_2012_9				
Action/Comments					
Note and monitor erosion site. Inspector Comments: Active erosion around irrigation inlet in levee prism.

10/26/2011 Active erosion into levee prism around irrigation inlet.

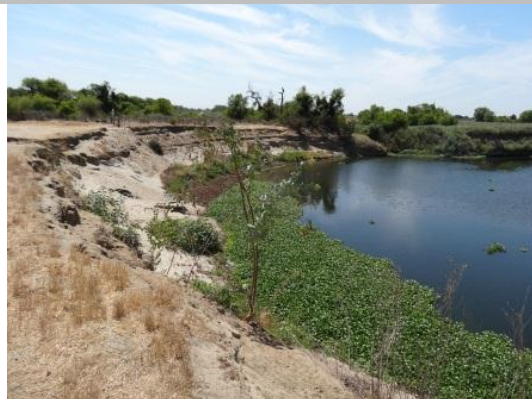
Photo 1 of 1 : SJR2014_RD2031U02RM78.7_1.jpg

LM Start	4.33	Rating **	A/W	Issue No.	1
LM End	4.37	Issue Type +	Ma	Location *	WS
Category	Supplemental			GPS Latitude/Longitude	
				Start	End
Item	DWR Erosion Survey			37.631716 °	37.631716 °
				-121.189370 °	-121.189370 °
DWR ID

Inspector Comments: 7/17/2014: The erosion has slightly expanded toward levee toe at two pocket locations.
09/10/2013: The site has been visited. The erosion has expanded toward levee crest at two pocket locations.
07/18/2012: No significant change observed on the site.
08/18/2011: No significant change observed on the site. Dead trees and animal activities are visible. The closest point of the erosion site to the levee toe is about 100 ft.
10/19/2010: There is active scouring occurring on the bank due to the nature of the flow and the lack of armor protection. There is also a fallen log immediately downstream of where the erosion has occurred and is protruding outward, possibly creating an eddy and scouring the bank. With the remaining 100-foot wide berm, the levee prism is not yet affected. However, the bank will continue to degrade, and eventually intrude into the levee prism if no protection is put in place. Erosion site is recommended for annual assessment and monitoring during flood events. [2014 Site ID:RD2031U02RM78.7]

Looking downstream. The erosion has progressed toward levee.

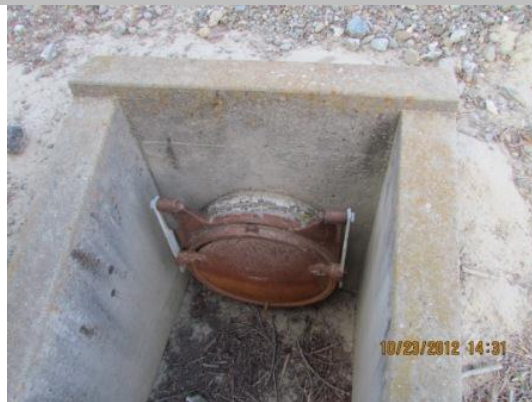
Photo 1 of 1 : FA_2014_RD2031_308_22_20141001_00012.jpg

LM Start	4.58	Rating **	A/W	Issue No.	22
LM End	4.58	Issue Type +	Ma	Location *	WS
Category	Earthen Levee			GPS Latitude/Longitude	
				Start	End
Item	Encroachments			37.630855 °	37.630855 °
				-121.185442 °	-121.185442 °
DWR ID	DWR RD2031 02 f 2012 22

Pipe
Inspector Comments: 36" discharge pipe through the levee with flap gate closed.

View of the closed flap gate on waterside.

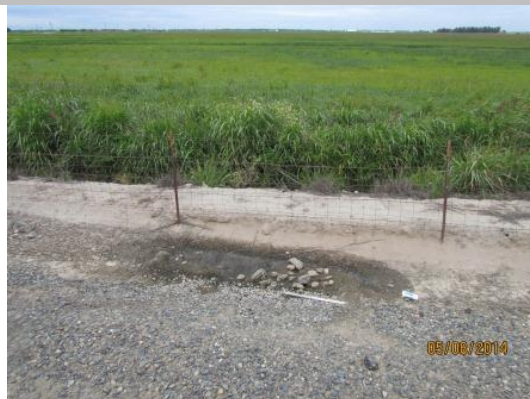
Photo 1 of 1 : FA_2014_RD2031_308_18_20141001_00011.jpg

LM Start	5.52	Rating **	A	Issue No.	18
LM End	5.52	Issue Type +	Ma	Location *	LS
Category	Earthen Levee			GPS Latitude/Longitude	
				Start	End
Item	Seepage / Sandboils			37.630802 °	37.630802 °
				-121.168439 °	-121.168439 °
DWR ID	DWR_RD2031_02_s_2014_18				
Action/Comments

View of the seepage at the landside levee toe.
